## Site Analysis - Constraints

## Movement

## Gillingham Town Centre Cross sections of the High Street

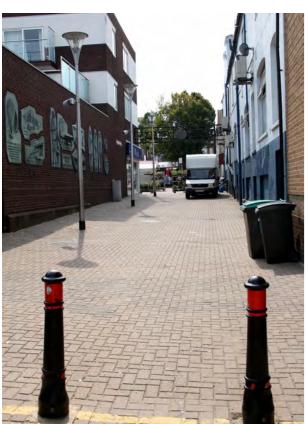
- Despite the potential for good accessibility from surrounding streets and public transport, the final links into the High Street are poor (e.g. Sappers Way, 1), and the southern side of Jeffery Street presents a poor and unattractive front which may compromise the High Street.

left to right: Sappers Walk; the footpath between Balmoral Gardens and Green Street; ; the road junction at the station; the pedestrianised area in High Street (East)

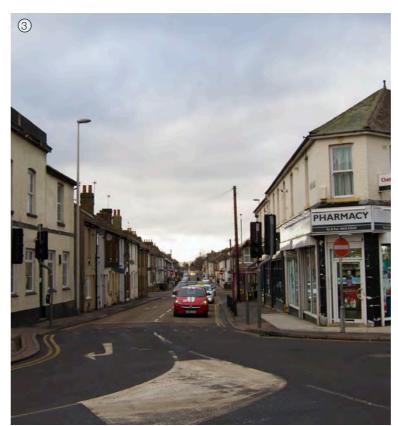
- The 'gateway' junctions to the town centre seem to prioritise traffic movement, and do not welcome those on foot into the town centre. At the western side, the priorities are unclear and traffic dominates; at the eastern end the railway station has a complicated road layout to the front alongside numerous different land uses which could be improved as the entrance to the High Street (3).

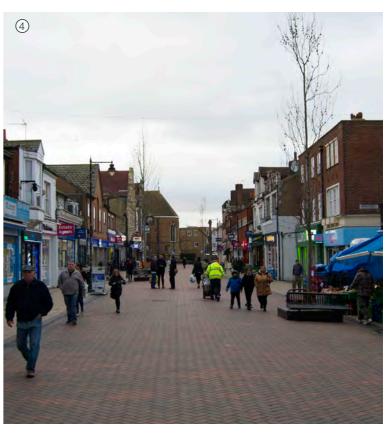
- The length of the High Street is problematic, as the distance between the station and Britton Street / Medway Park feels too long. The lack of footfall and variety and the poor quality overall contributes to this perception of distance (4). Additionally, there is no opportunity currently for circulation or variety in routes the shopping centre is a linear street and little else.
